Geospatial Technology for Climate-Resilient Road Infrastructure Management and Planning in the Inland Regions of Papua New Guinea

Tingneyuc Sekac, Sujoy Kumar Jana
Papua New Guinea University of
Technology,

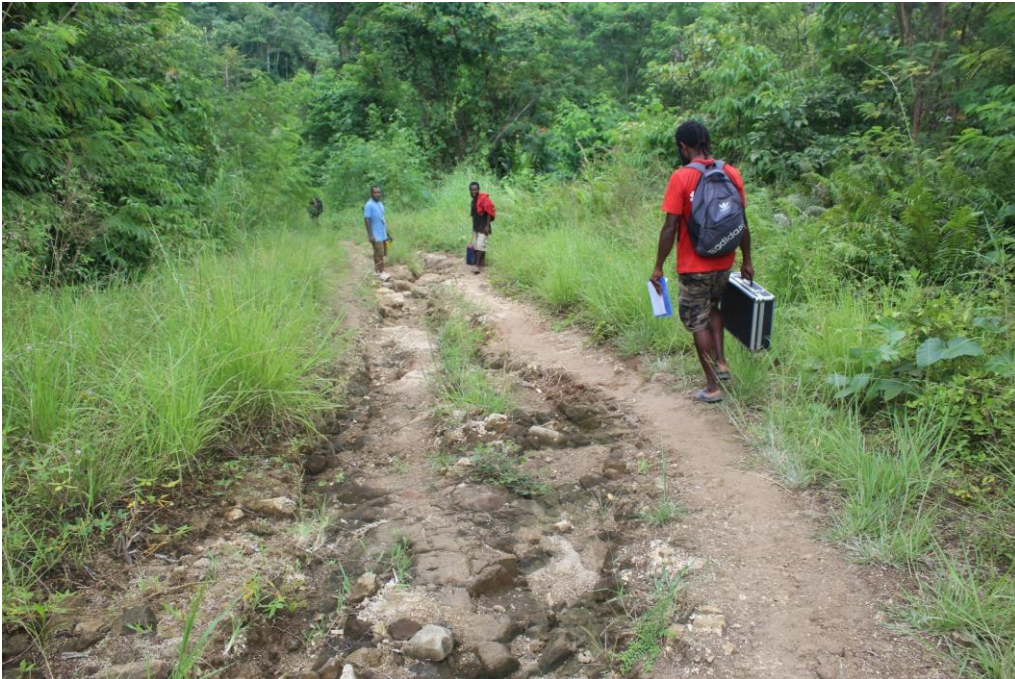
Current construction cannot withstand rainfall weather pattern

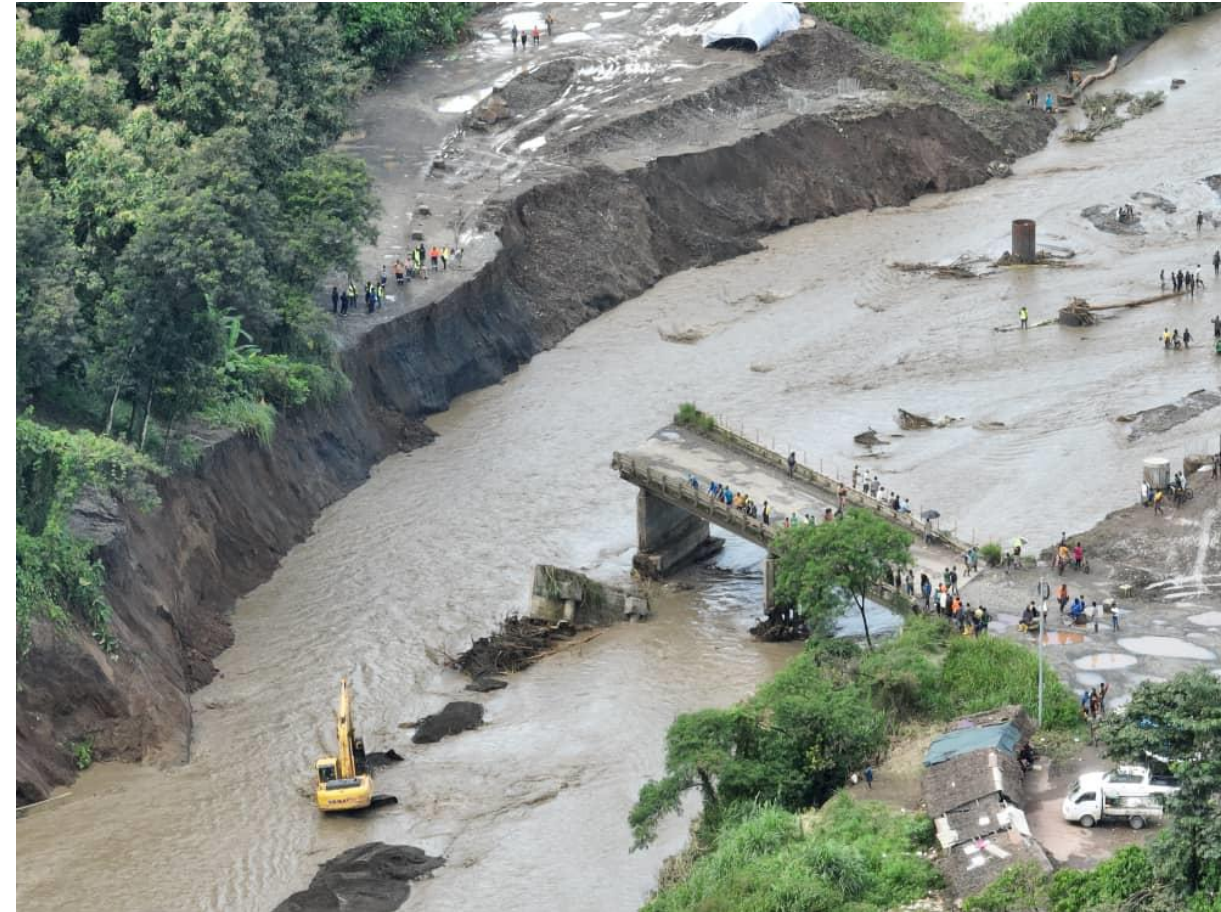
Approx. 70 years Bridge has collapsed-2024

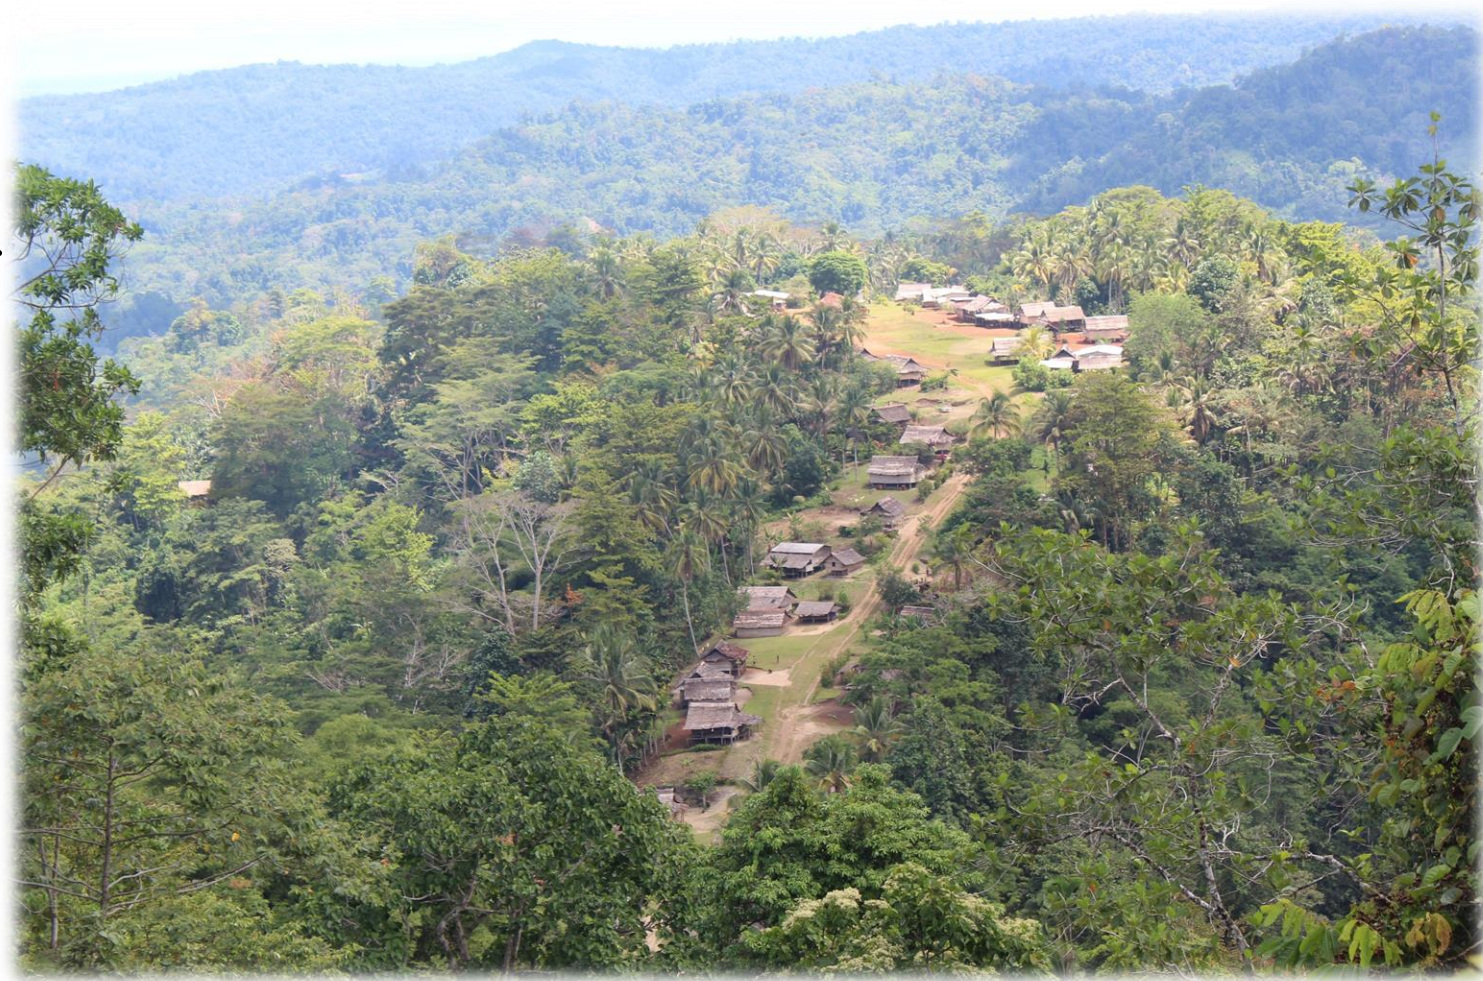
- ❑ Connect PNG - Connecting rural population with road infrastructures.
- ❑ Connecting roads across terrains is challenging.
- ❑ Many roads are initially constructed but fail due to continuous rainfall, resulting in collapses.

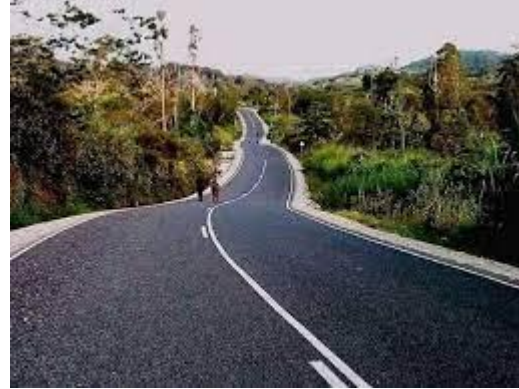
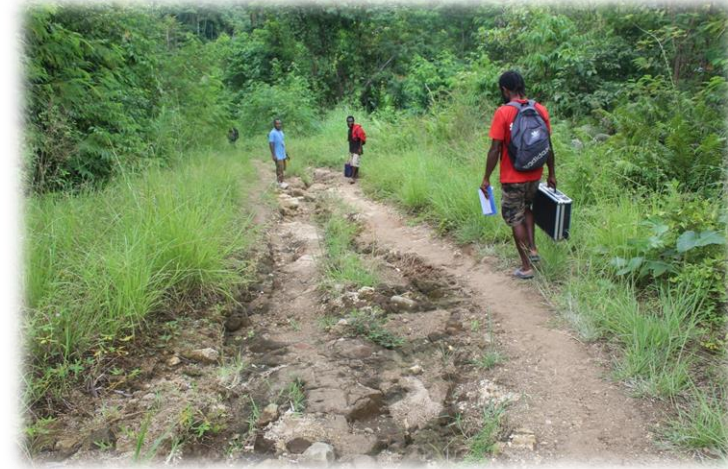
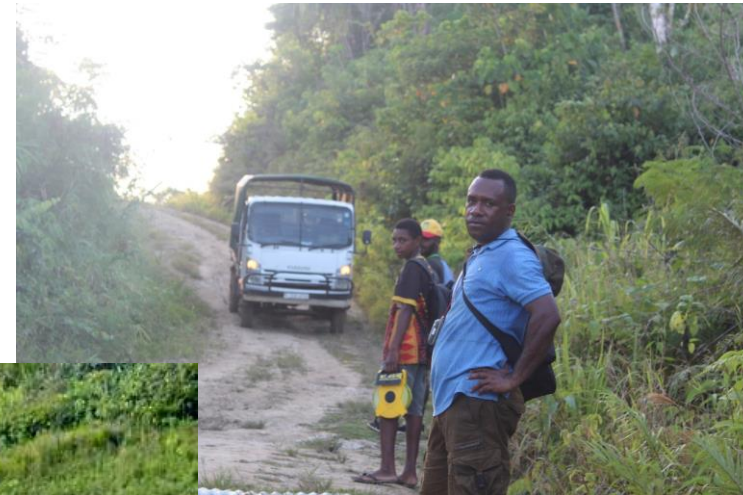
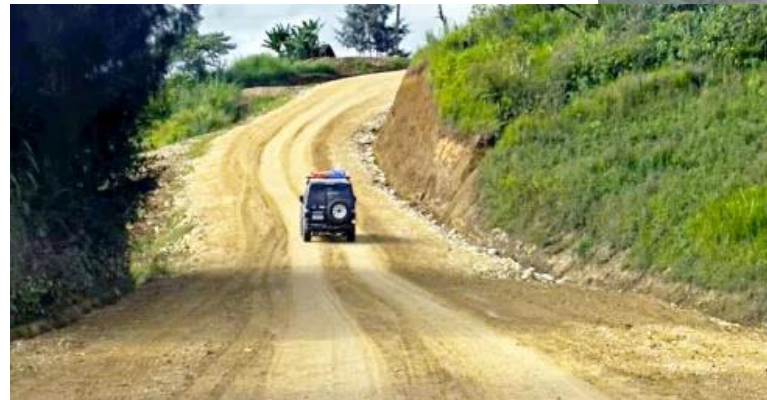
- ❑ Developing and Keeping up to date inventory database;
- ✓ Identifies repair needs and optimizes resource allocation.
- ✓ Helps in planning future expansions and upgrades.
- ✓ Minimize hazard and transport risk
- ✓ prioritize spending on the most critical repairs
- ✓ selecting the most safest and least cost road network

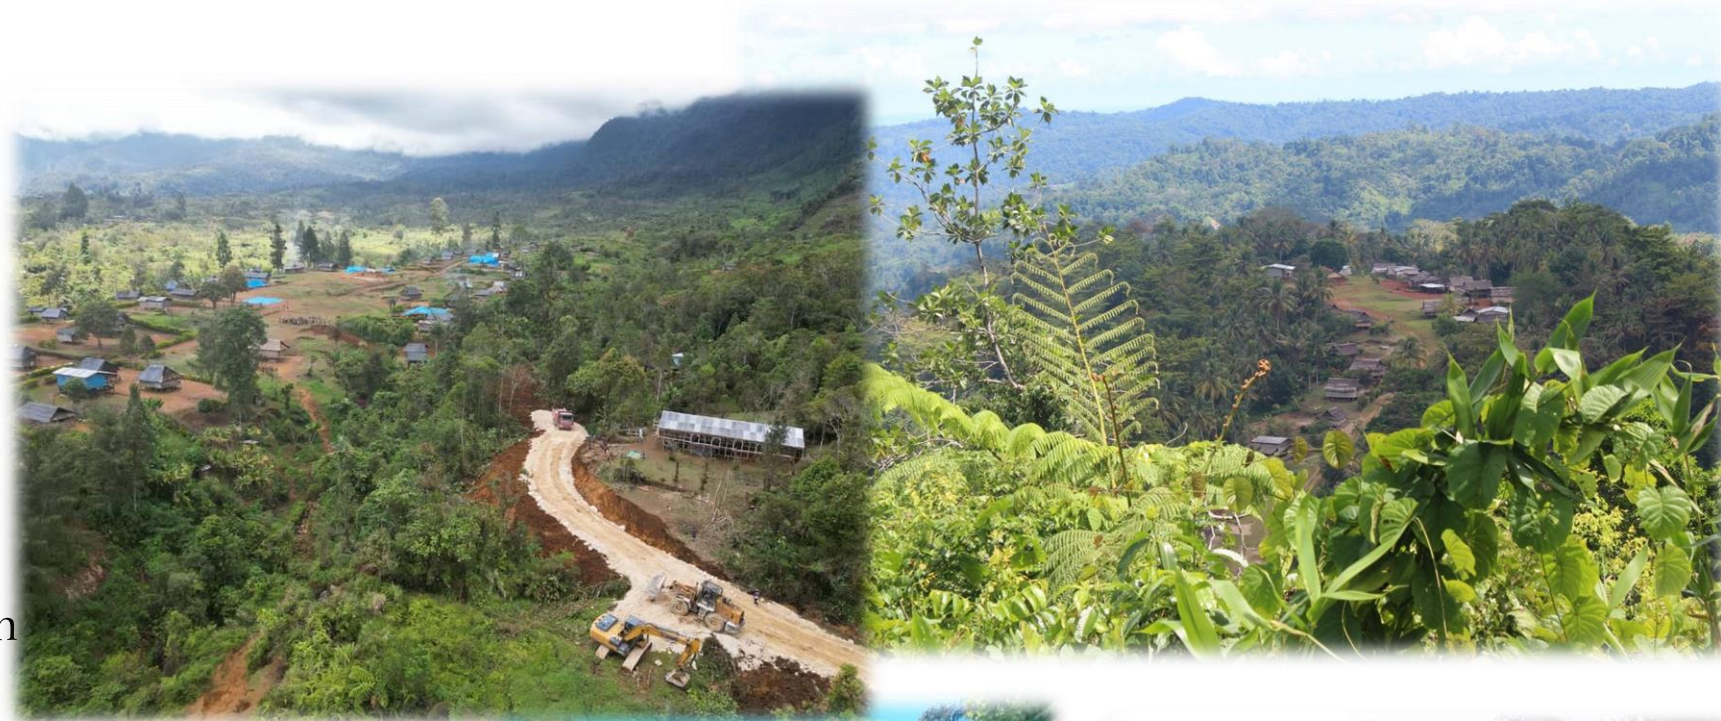
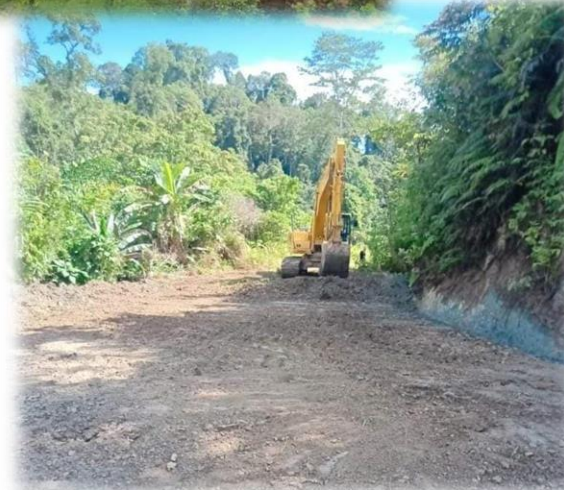
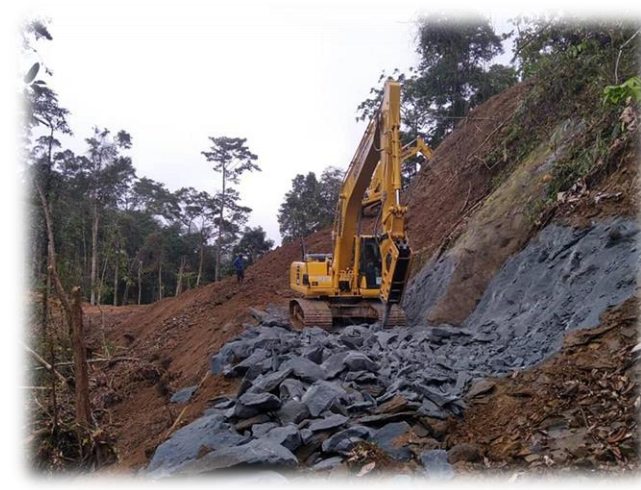
❑ Before new cut road, consider;

- Slope Gradient/Topography
- Creek/river(Hydrology)
- Land use/land cover type
- Land issue/restriction
- Site soil geology
- Reaching enough population

❑ Proper road alignment selection stage is critical.

❑ Route alternatives are compared to minimize negative impacts and select the most suitable path that can be climate resilient.

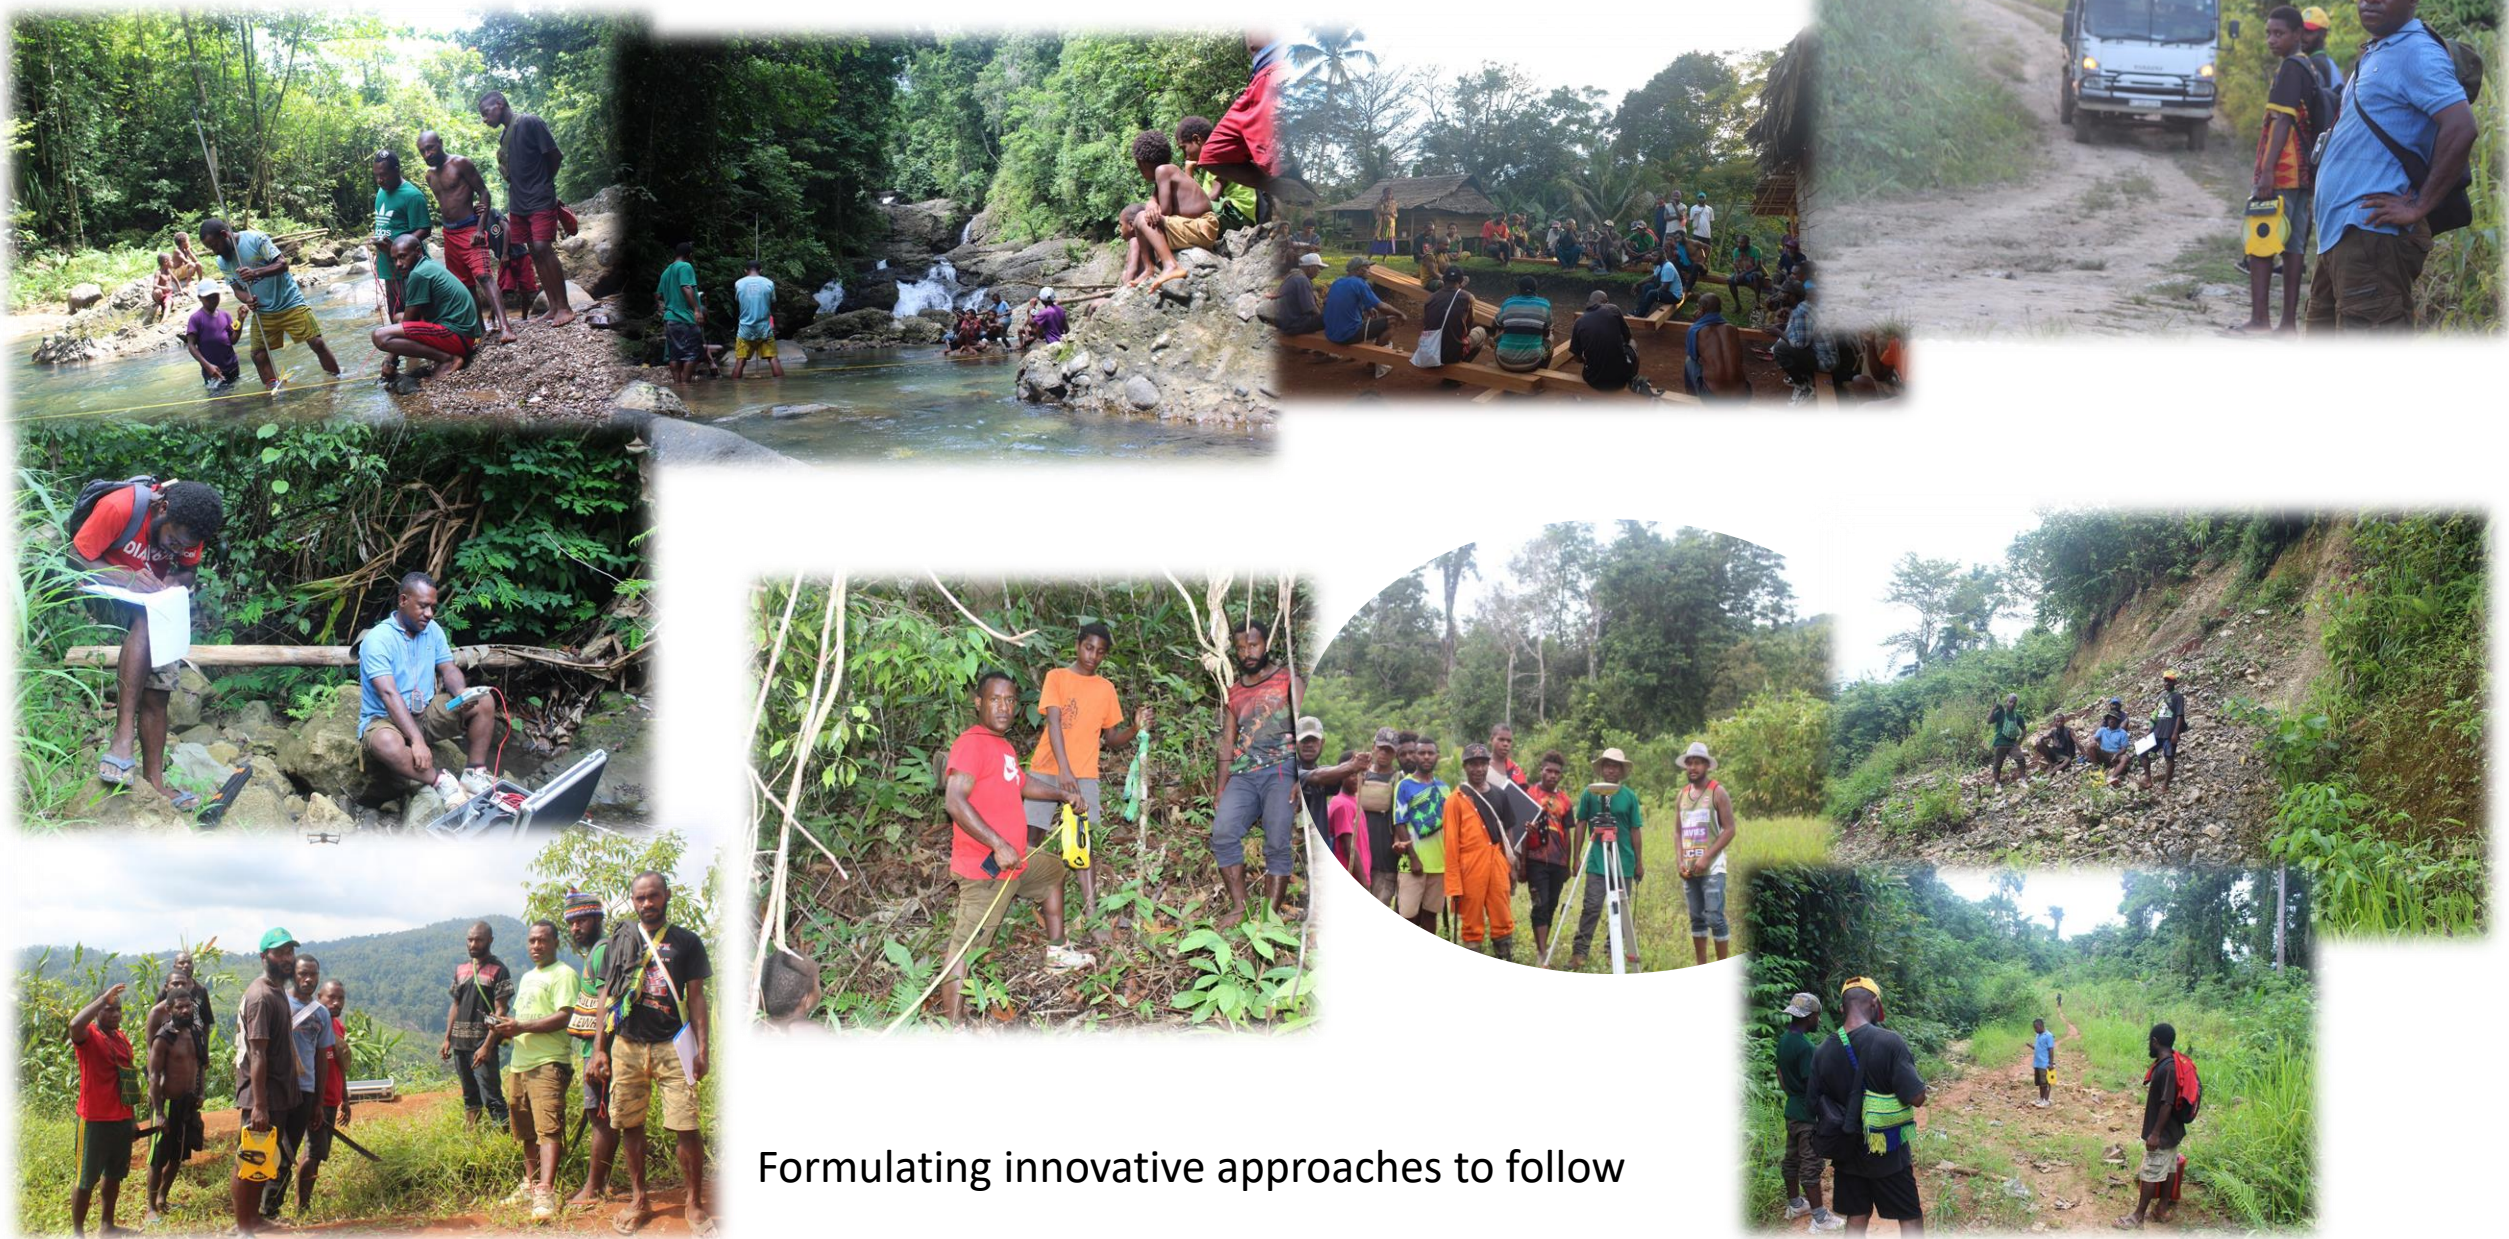
CASE STUDY METHODS – FIELD DATA

Formulating innovative approaches to follow

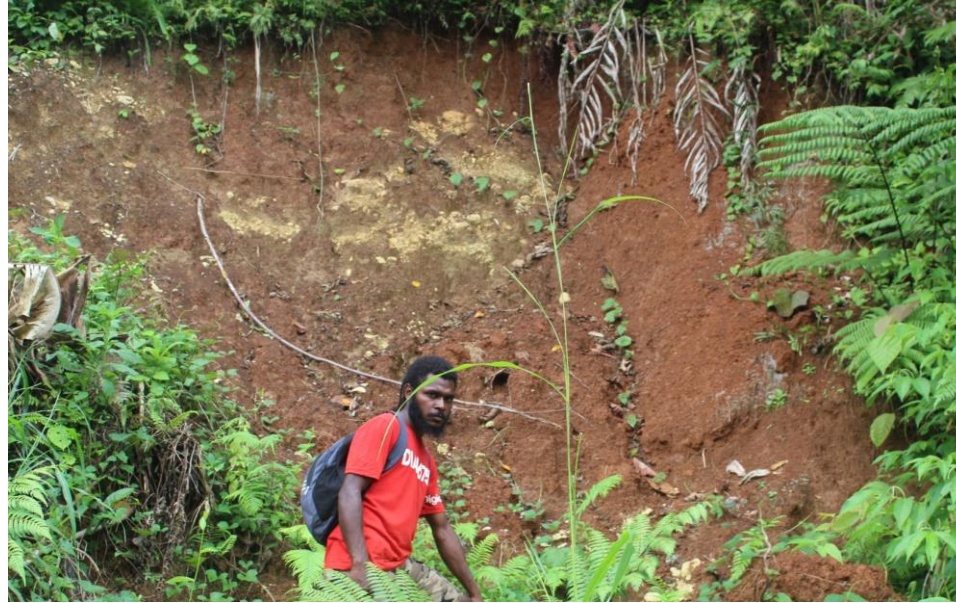
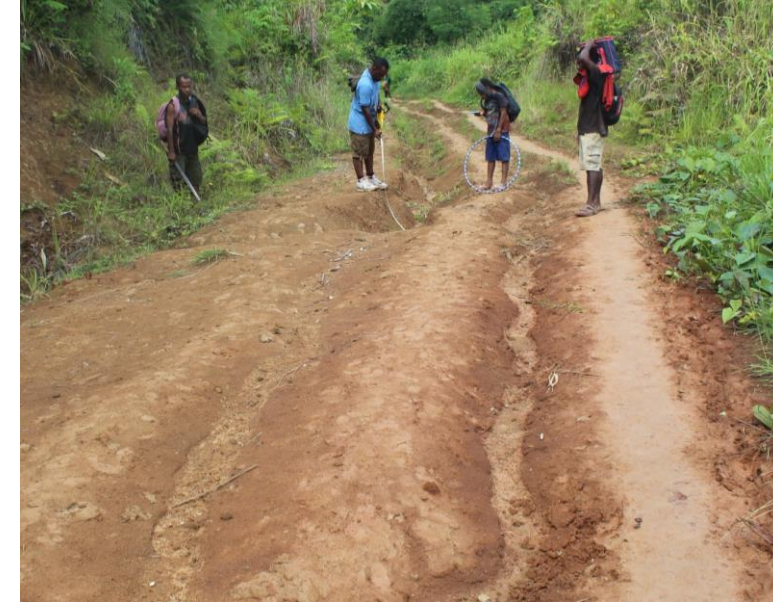
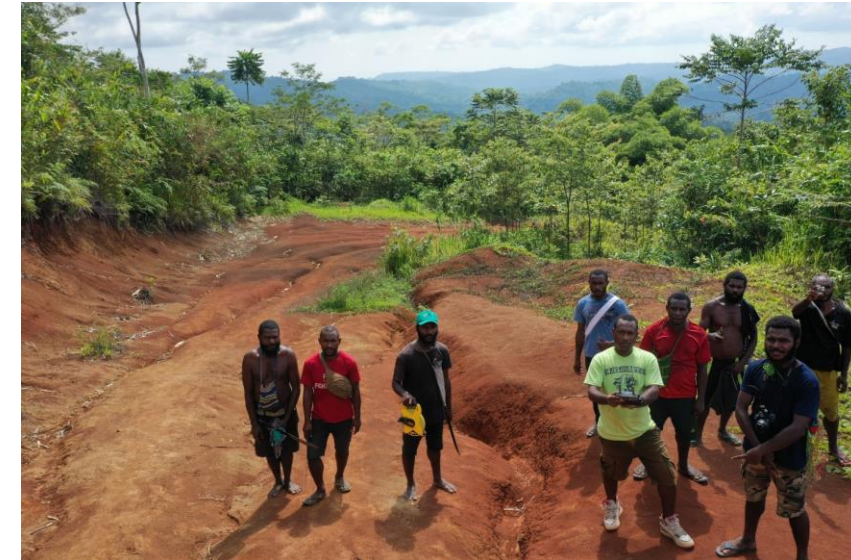
❑ Geology/Lithology Desc.

- ✓ Geological Formation: Fine Calcarenite (Limestone-sand size particles of CaCO_3):
- ✓ Low bearing capacity
- ✓ High susceptible for weathering and erosion

❑ Great Soil Group

- ✓ Rendolls are lime stone soils
- ✓ Trophents are high weathered soil – weaker structural properties

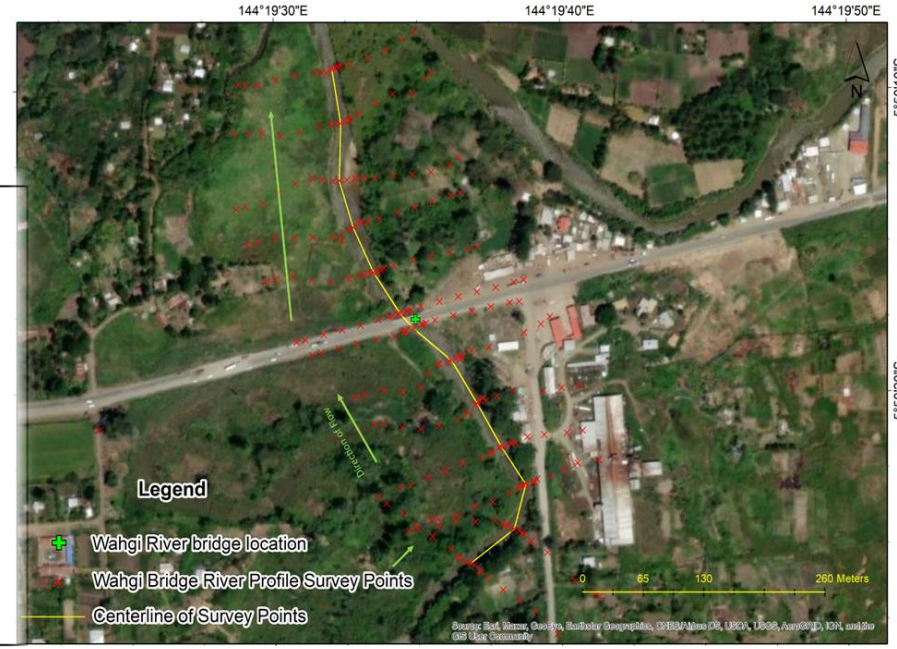
BRIDGE DESIGN WITH HYDROLOGICAL DATA INPUT

☐ Catchment hydrology – Bridges Design

- ✓ Peak discharge
- ✓ Cross section
- ✓ Rainfall/Flood duration
- ✓ HR/Scouring
- ✓ GeoHECRAS – ArcGIS Plugin

Reduce Level 0 RL=1695.42
HR=12.04/23.56
HR=0.51
